Learning Lessons from Derna Dam Failures

*Essam Saeid^a, Khalifa Eldursi^{1a}, Taoufik Al Trabelci^b

^a The University of Benghazi, Department of Earth Sciences, Benghazi Libya

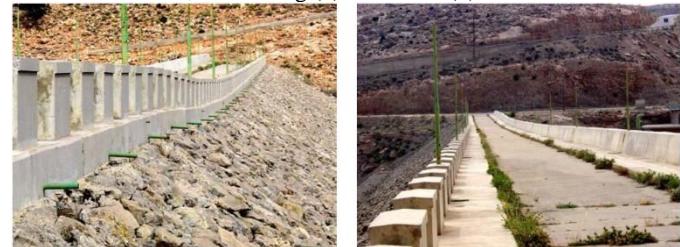
structural. The overtopping is the main factor due to the huge amount of precipitation that is beyond the dams' capacities. However, other factors such as piping and foundation deficiency may play a significant role in the failure of both dams. Studies indicated that both Dams experienced fatal problems in the dam's bodies, and foundations. However, according to [11], and [12]. the clay core of the dams shows low plasticity so the clay sensitivity was low. [18], and [19] geotechnical investigation study of the Derna and Abu Mansur dams indicated that there are two zones of clay core, the upper (Fat Clay) and the lower (lean clay). Diversification of clay cores reported in both zones, also during their drilling program noted that the retrieved core was wet, soft and soaked clay. These phenomena can be caused by the difference of material composition, their compaction and fissures or joints in the main dam bodies. Also, the permeability test of the (clay core sample) of the dams ranged from 1.3 E-05 m/s to 8.9 E-09 m/s . However, they drilled in both dams to depths of 23m to 65m but did not reach the intact rocks at the foundation level to investigate the dam settlement. Reports of the General Water Authority (1995) and Stuck (2003, 2004) indicated that there are horizontal deformation and vertical settlement in both dams especially Abu Mansur dam Fig (3). The failures of the Wadi Derna Dams are typical of the phenomenon of overtopping (spillway capacity or non-functioning floodgate). Other factors including internal erosion results from dangerous seepage of water (to the Dam core) by either cracking due to differential settlement and leakage either through the foundation/core contact plane.

Fig. (3). Abu Mansour Dam vertical deformation as seen from the right abutment (A) and horizontal deformation as seen from the left abutment (B) after [11].

However, all the studies [10-17], made a series of recommendations for urgent rehabilitation of both dams such as heightening of dams and increase the flood discharge capacity by new spillways in both dams but none of the recommendations performed.

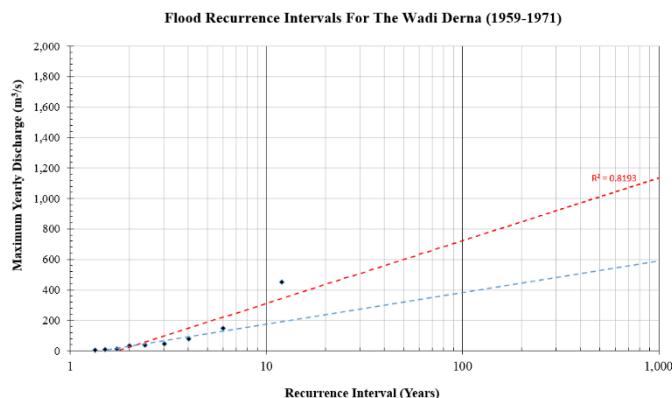
Fig (4) Flood recurrence intervals for the wadi Derna (October 1959 to 11 April 1971 (The blue and red lines are the lower and upper limits of the (extrapolated) curve to estimate the 1000 years flood at cubic meter per second.

The flaws of the dam's design by [6-9] were initially due to the limited data of the wadi Derna discharge in that time. The 1972 study, which identified the primary hydrological events in Derna City (from 1959 to 1971), with the largest occurring in October 1959, served as the basis for the design (Fig 4, Table 3).

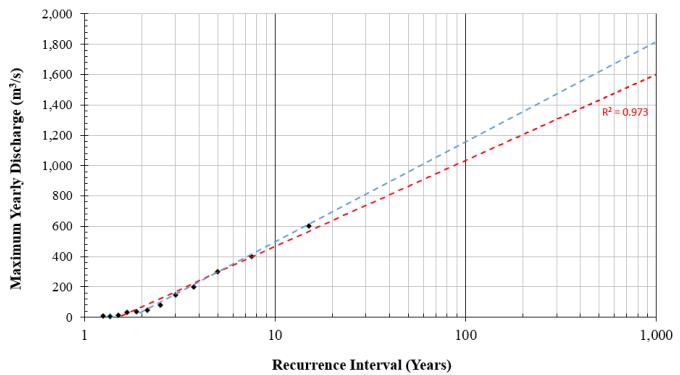
in 1986, 2011, and 2023—Table (4) will not reflect the dam's initial design parameters. However, based on flood new recurrence intervals of Wadi Derna the 1000 years' flood estimated between 1700 to 2000 m³/s, Fig (5) which are above the design maximum flood estimated by [6] and the recalculated by [10-16].

Fig (5) Flood recurrence intervals for the wadi Derna (October 1959 to 11 September 2023)(The blue and red lines are the upper and lower limits of the (extrapolated) curve to estimate the 1000 years flood at cubic meter per second.
