Analyzing the Effect of Water on Stability of Rocky Slopes and Simulating Collapse: A Case Study of the Debris Slope Parallel to Rujban Mountain Road –NW Libya

On December 11, 2023, a sudden collapse occurred in a parallel rocky slope adjacent to Rajban Mountain Road, leading to the closure of the road section. This prompted the research idea of simulating the collapse and the influencing conditions to assist in understanding the collapse occurrence. This paper discusses the utilization of practical methods and the 'Rock Plan' software to simulate the stages of slope failure. The analysis of simulation outputs reveals the impact of moisture content on the factor of safety and the relationship between driving forces and resistance. This paper highlights the importance of resistance strength in maintaining slope stability and how it diminished under the influence of rainfall pressure and a 65% increase in moisture content, which resulted in the slope collapse. The results demonstrate the influence of internal cohesion and friction angles on slope stability, identifying them as the primary factors contributing to the collapse. The study emphasizes the importance of using laboratory e

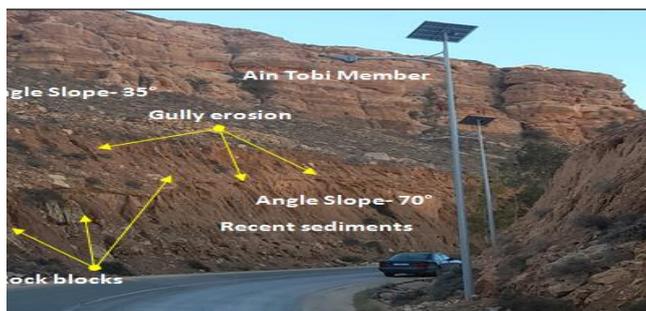
Fig. 1: A section of Rujban Mountain Road The collapse. led to road closure, and the debris was removed by road users while burying natural drainage channels.

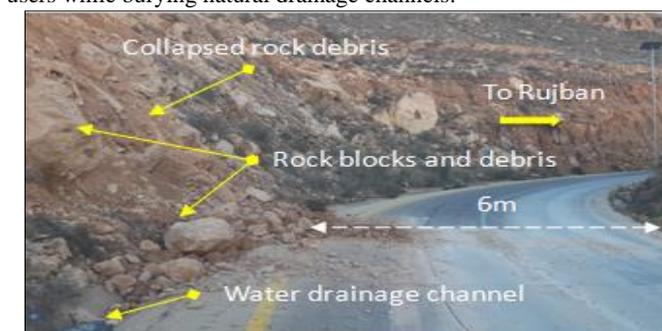
Fig. 2: Rock Debris Collapse at the Study Area Site

Parallel and adjacent slopes to mountain roads are considered as high risk areas, where the sliding rock debris is prone to sudden and rapid collapses, leading to serious accidents and traffic disruptions [1]. Several factors contribute to the occurrence of slope failures parallel to mountain roads, including the type of soil and rocks, as the stability of slopes is influenced by their characteristics such as porosity and permeability [2]. Rainfall is also a major factor affecting slope stability and hence water-saturated soils are more likely to lead to slope failure [3]. According to reference [4], heavy rainfall increases water pressure in soil and rocks' pores, especially rocks with moderate to high porosity, resulting in reduced cohesion. Reference [5] confirms that water pressure reduces the cohesion of soil and rock components, increasing the likelihood of slope failures. Earthquakes are another factor that causes increased vibrations and changes in soil and rock pressure, leading to the accumulation of stress and subsequent slope failures [6]. Chemical and mechanical weathering processes, as well as weathering factors, contribute significantly to the destabilization of slope components. These factors include wind and rain, especially rill weathering, which penetrates slopes and reduces their stability [7]. Human activities also contribute to increased hazards of slope failures, such as the removal of vegetation cover, which is essential for slope stabilization [8], or altering and blocking natural drainage channels or cutting slopes to extend mountain road paths [9]. The interaction of both natural and human factors can affect the stability or collapse of slopes and may be the cause of parallel slope failures along mountain roads [10]. For instance, the Rujban mountain road, as shown in (Figure 1), experienced a collapse of rock debris on 11/12/2023, with the debris extending for a distance of 6 meters (Figure 2) [11].

Observations also reveal that rock masses on the slope may collapse at any time. This collapse occurred on a rainy day, with recorded rainfall of 80 mm [12]. The research problem lies in the sudden collapse that occurred on a slope parallel to the road and the presence of similar rocky slopes that could potentially collapse in the same location or adjacent slopes. Therefore, the research problem raises the following questions: Can the stages of rock debris collapses be simulated at the site? Can the collapse occurs again on adjacent slopes? Finally, is there consistency between the results of laboratory experiments and computer simulations in evaluating slope stability and collapse? To answer these questions, research objectives have been formulated, including determining the values of internal friction

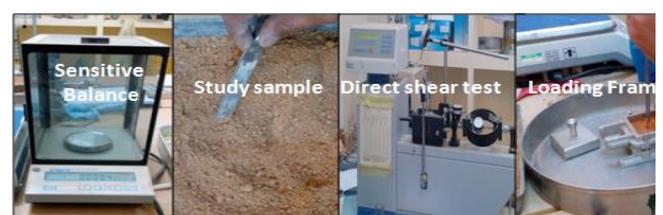
Fig. 4: Some devices and equipments used in the laboratory

1.2: Laboratory Study. This stage focused on calculating the values of friction angles, internal cohesion, and water content % for the dry sample and when adding different quantities of water to the dry sample (5mm, 20mm, 50mm, 80mm). The important materials and equipment used are illustrated in (Figure 4).

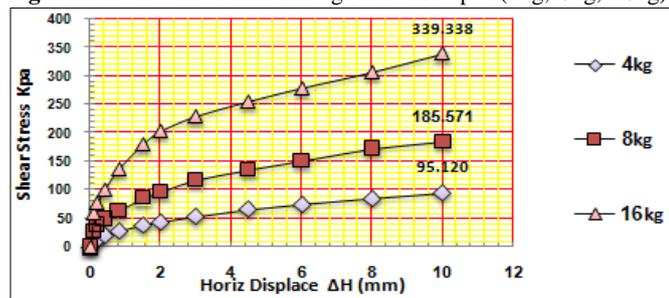
Fig. 6: Relationship between normal and shear stress at 2.8% saturation.

In the first step a sample was taken from the collapsed debris and immediately placed in a bag approximately eight days after the collapse occurred. A portion of the sample was then taken and put into an Furnace for 24 hours at a temperature of 120°C to dry it out. The moisture content was calculated by weighing the sample before and after drying, the result was recorded. In the second step: a portion of the natural undisturbed sample, without drying, was taken. Tests were conducted on this sample to determine the relationship between the normal stress and the shear stress resulting from the applied load using the Direct Shear Test apparatus, as described in reference [19]. The tests were carried out at a constant loading rate of 0.25 N/cm² using a loading frame with an area of 36 cm², as shown in (Figure 4). Variable vertical loads (4kg, 8kg, 16kg) were applied, as shown in (Figure 5). The values of the friction angle (φ) and internal cohesion (C) were extracted using a pre-prepared Excel model, as shown in (Figure 6). The results were recorded in Table 1 in Table 1

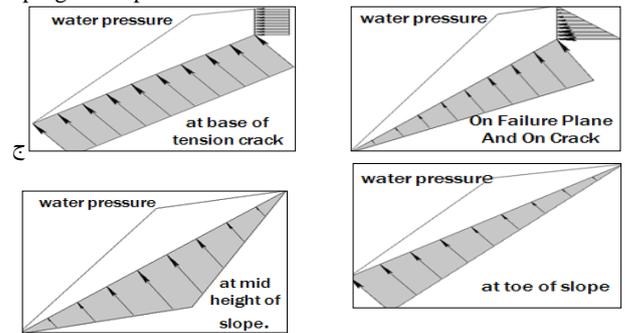
Fig. 7: Water pressure distribution on the failure plane and cracks[21]

identify crucial stability factors and evaluate the current level of slope stability according to predefined safety metrics. It enables simulation of the impact of different variables on the stability of rock slopes[21]. Users can modify parameters of slope geometry, shear strength, water pressure, and external forces to determine the most favorable scenario for enhancing slope stability[21]. Moreover, the program excels at analyzing past slope failures, allowing users to investigate and comprehend the causes of such failures. The information derived from the program can be utilized to assess the stability of similar slopes and implement appropriate preventive measures[21]. It is worth noting that the program simulates the effect of water pressure on slope components in four stages, depending on the location of water pressure concentration: on the failure plane and on the crack, at the base of tension crack, at the toe of the slope, and at mid-height of the slope[21]. (Figure 7). and the most important data on which the program depends is listed in the table 2.

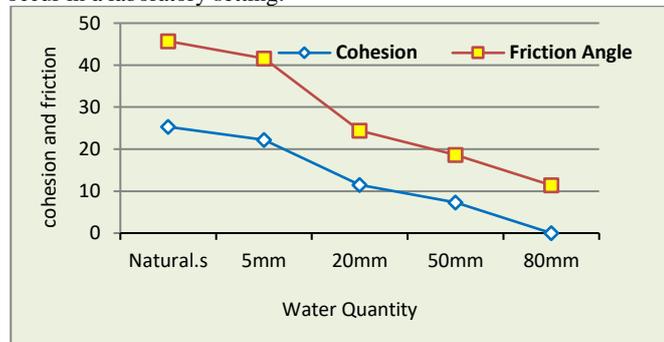
Fig. 8: Relationship between water quantity and cohesion -friction

applied by the Direct Shear Test apparatus. When increasing the water quantity to 5mm for the dry sample, both cohesion and friction angle values decreased, but the change was minimal compared to the dry sample as shown in (Figure 8). This is due to the dry sample's ability to absorb the 5mm water quantity. The noticeable change occurred when adding 20mm of water, resulting in a significant decrease in internal cohesion to 22.2 t/m² according to Table 1. This decrease is more evident when examining (Figure 8), which coincided with a slight change in the friction angle value. The decrease in cohesion can be attributed to the roughness of the sample, which resists the collapsing process. Further increasing the applied stress on the sample by adding 50mm of water led to the sample reaching a state of suffocation due to the exerted forces and the high water content, which reached 23% according to Table 1. Once the Water content ratio inside the sample reached 56% it completely lost its cohesion, as shown in (Figure 8), and the friction angle decreased to be 11.4°. It is worth noting that the mixed debris porosity played a role in not retaining high water content, resulting in a relative increase in density (Unit Weight) in Table 1 with each change in water quantity. It is important to emphasize here that the changes in friction angles and internal cohesion are influenced by the water content ratio retained by the sample, rather than the added water quantity. The sample did not reach a saturation level of 100% in all cases, yet Failure occurred. Therefore, we can conclude that the cohesion and Failure of the sample are closely related to the water content it contains, which is the crucial factor for slope failure to occur in a laboratory setting.

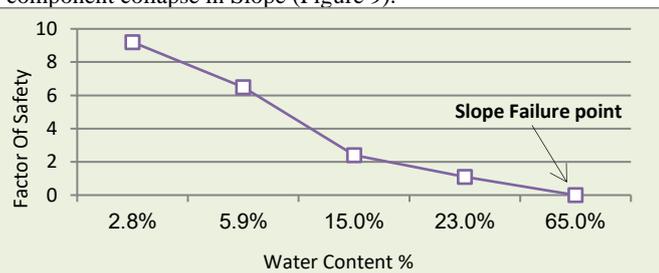
Fig. 9: Relationship between factor of safety and water content %

The utilization of the Rocplane Software allowed for the simulation of slope collapse. Analyzing the outputs presented in Table 3, we observe a significant alteration in the Factor of Safety. Initially, the Factor of Safety reached its peak value of 9.2 when the water content was 2.8%. However, as the water content ratio reaches to 65%, the Factor of Safety dropped to zero, coinciding with the occurrence of component collapse in Slope (Figure 9).

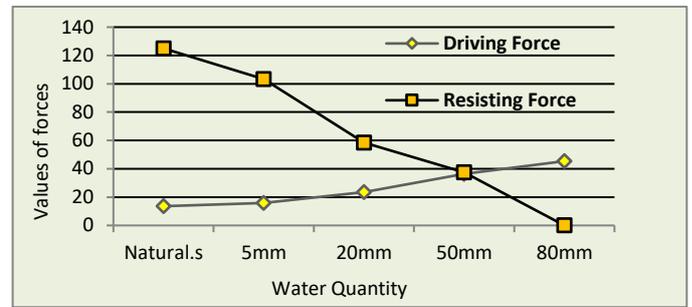
Fig. 10: Relationship between driving and resistance forces

The observed change in the Factor of Safety values was caused by a strong inverse relationship between the resistance force against collapse and the driving force, as shown in (Figure10). As the driving force increased, the resistance force decreased, leading to a decrease in the safety factor. The relationship between the driving force and the resistance force is influenced by changes in water quantity. When the water quantity increases in the slope, it negatively impacts the resistance force against slope collapse. This is due to several factors, including the increase in weight resulting from the load caused by the higher water content percentage.

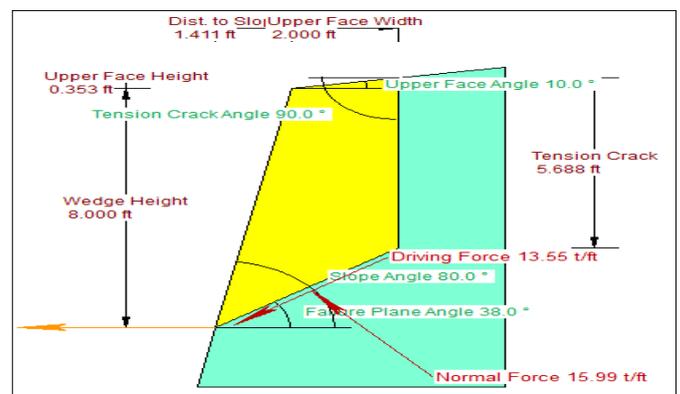
Fig.11: Simulating a natural slope affected by a water content of 2.8%

The resistance force played a crucial role in maintaining the stability of the slope. Through the analysis of the data in Table 3, we find that the resistance force in the natural condition of the slope was 125.8 t/ft, which is a substantial force compared to the driving force that triggers collapse, which was 13.58 t/ft. The resistance force remained constant, ensuring the stability of the slope, and there was no significant impact from the water quantity or water content ratio on the collapse (Figure 11).

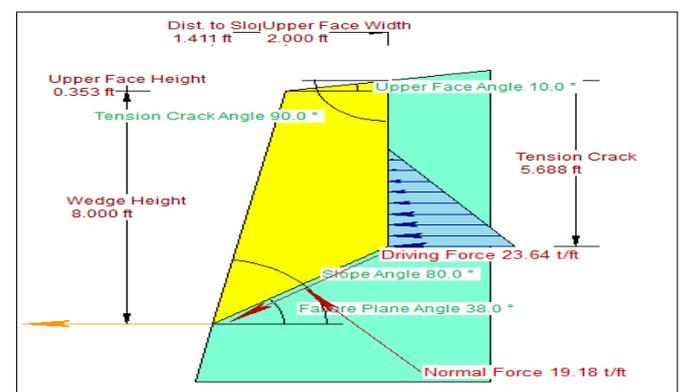
Fig. 12: Simulating a natural slope affected by a water content of 15%

The actual and influential effect of the driving force began with a value of 23.6 t/ft, coinciding with a decrease in the resisting force by 58.4 t/ft and an increase in Wedge Weight by 29.6 t/ft (Table 3 and Figure 12). We observe the effect of water resulting from rainfall, which acted as a driving force concentrated below the tension crack. Field studies revealed that the tension crack is a discontinuity located at the top of the slope, reaching a depth of up to 5.6 meters. This discontinuity was formed due to water erosion factors, leading to the weakening of the slope, facilitating water infiltration, and increasing the moisture content of the slope components. However, the failure plane was not affected by rain water pressure (Figure 12).

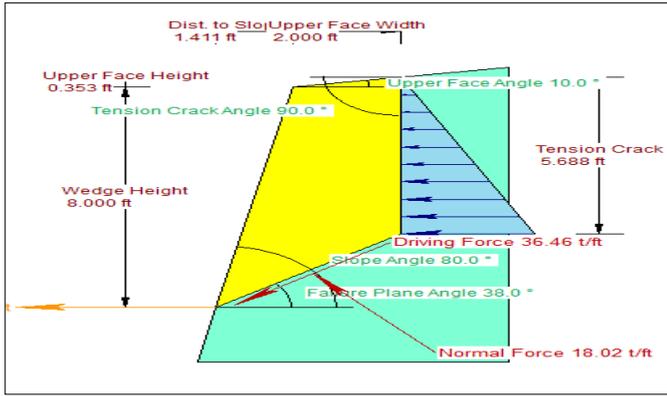
Fig. 13: Simulating a natural slope affected by a water content of 23%

The effect of rainfall water pressure increased when the water quantity reached 50mm, affecting the entire tension crack (Figure 13) This is due to the increased water quantity and water content within the slope components. Simultaneously, the driving force increased by 36.4 t/ft, while the resisting force decreased by 37.6 t/ft, resulting in

a decrease in the safety factor to 1.1. As a result, the slope approached the point of failure.

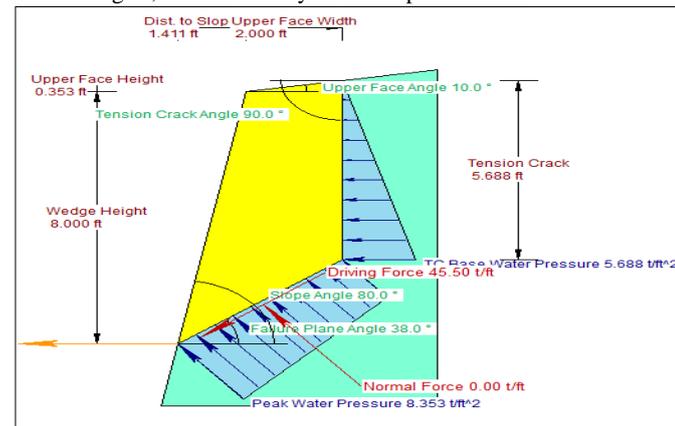
Fig. 14: Simulating a natural slope affected by a water content of 65%

By observing (Figure 15), the clear impact of rainfall water pressure is evident on two locations: the tension crack and the Collapse plane (Figure 14). This leads to an increase in the driving force, reaching a value of 45.4 t/ft, while both the resisting force and cohesion vanish, resulting in a value of 0 t/ft Table 3. The internal cohesion collapse occurs with a value of 2.1 t/m² and a Factor of Safety of 0. It is evident that the collapsed slope was affected by the rainfall water pressure. The effects started to manifest when the slope was exposed to a water quantity of 20mm, continuing through 50mm, and resulting in the collapse of slope components at a water quantity of 80mm. The slope was also influenced by the water content, affecting cohesion, friction angles, and the density of the slope materials.
