وقائع مؤتمرات جامعة سبها
Sebha University Conference Proceedings

Evaluation of existing steel structure building through safety of bolts at connections

Altawil Zaid Altawil

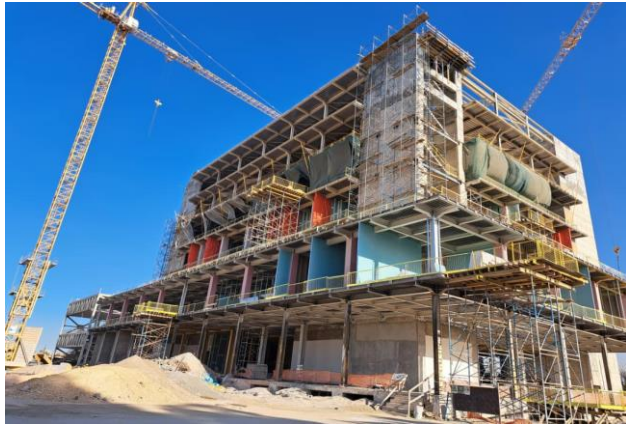
Figure (1) : Existing steel structure building (5TH and 6th floor constructed recently based on designer decision).

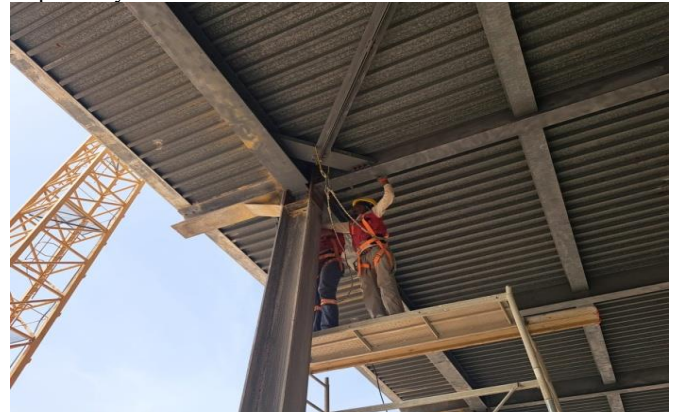
A number of 6 samples of bolts have been taken from connections of **beam to column** for each floor of building which consist 6 floors (from basement to 4th floor), and 6 samples of bolts have been taken too from connection of **beam to beam** for each floor, so a total of 70 samples have been taken based on visual inspection, a different size of bolts have considered during collection of samples (16 mm, 20mm, 24 mm). All bolts which have been taken as samples were founded from **Grade 5.6**.

Figure 2(A): Samples from beam to column connection

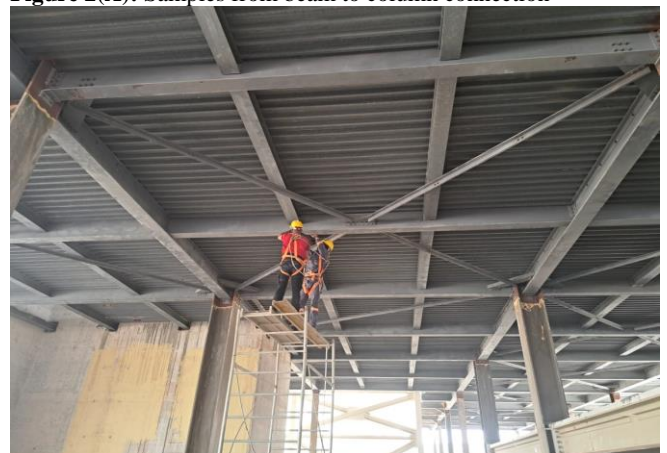
Figure 2(B): Samples from beam to beam connection

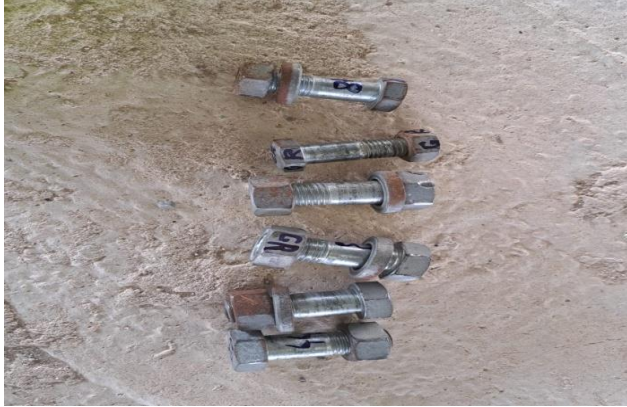
The collection of samples is shown in figure (2a and b) the non corrosive and corrosive bolts are also shown in figure (2 c and d) respectively below:

Figure 2(C): Non Corrosive bolts

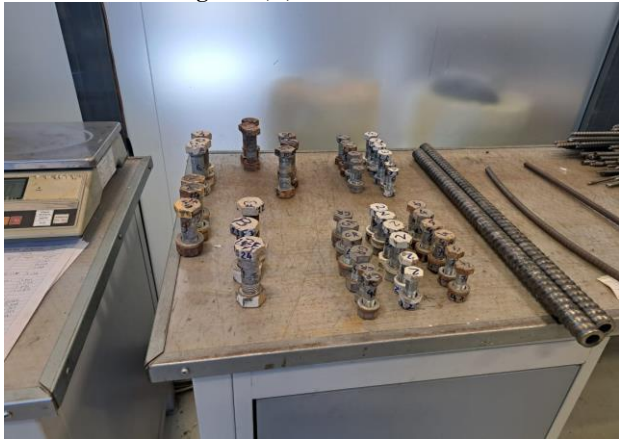
bolts, so check of connection safety through bolts test became very important, specially some bolts noted with corrosion at edges of building and near hinges where some humidity spread on steel structure and connections, some bolts are not tightened well.

According to Swamy, R.N [3] who considered that RC beams strengthened with steel plates exposed to weather condition for a period of 11 years (which is long – term exposure) as durable beams. So corrosive bolts (see fig 2D below) can be also accepted as durable bolts, and corrosion can be solved with sandblasting.

Figure 2(D): Corrosive bolts.

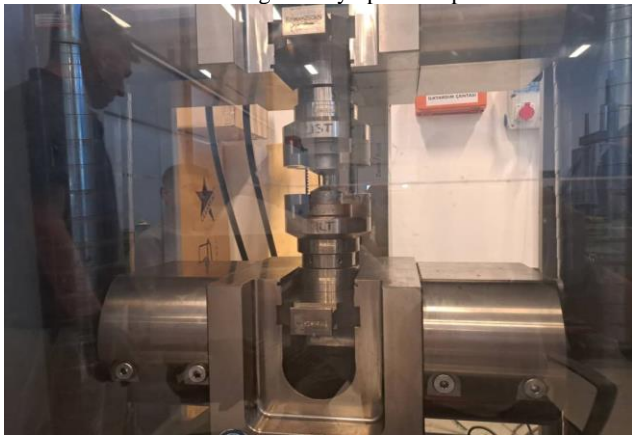
Due to length of bolts which considered so short for local laboratories, all bolts were transported to Turkey, exactly at Istanbul Technical University (ITU), and due to experience at dealing with shorts samples the bolts taken to Materials Testing and Innovation Laboratories (MATIL). Then the Bolts were tested, they were loaded under tensile force gradually up to complete failure.

Figure (3) : Tensile testing machine with an extension parts to test short samples.

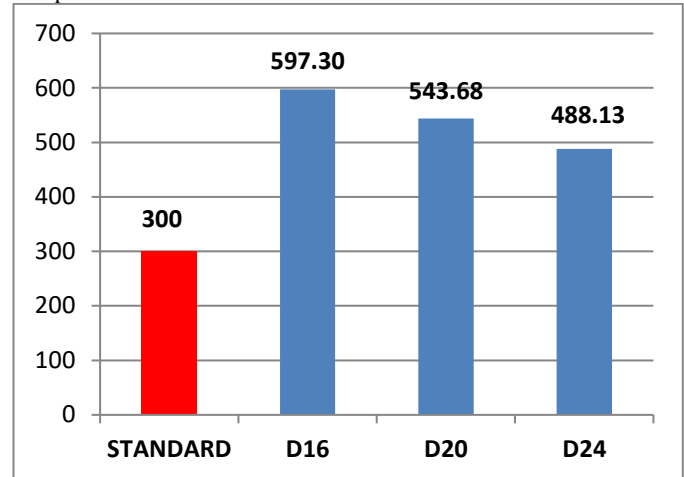
ISO 898-1:2013 [E] [2] shows that yield stress of bolts of Grade 5.6 should be minimum 300 MPa as indicated in table (2), results showed that the minimum yield stress value is above 400 MPa, and the maximum yield stress value is above 700 MPa. These results are so good that these bolts do not need to be replaced in the building. Figure (4) shows yield stress average in MPa for each bolt size

Figure (4): shows yield stress in MPa of all bolts compared with Bolts standard

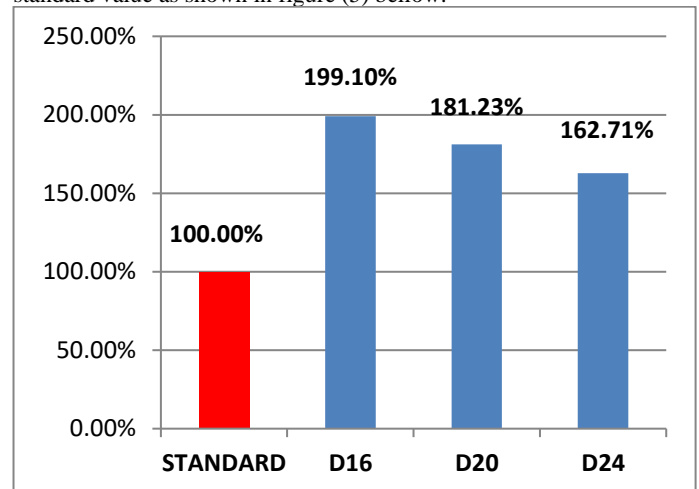
Figure (5): shows yield stress of all bolts as percentage From bolts standard

From figures (5 and 7) shown above all bolts yield stress is higher than yield stress according to standard with minimum 63 %, and tensile strength is higher than tensile strength according to standard with minimum 22 %, in all tested bolts the average of elongation is above 20 % which also satisfied specification of bolts, this gives indication that bolts still in good condition that do not need to be replaced during maintenance of building, and based on results bolts grade can be named as **Grade 6.8**. This can be interpreted that during the period of building construction (1980s) the writing on bolts during manufacturing them used less Grade which is 5.6 as factor of safety, because the method of design at that time which was commonly used was working stress design which based on reducing the strength of material for about 50 % .

Based on the ratio of ultimate failure stress and yield stress of tested bolts to tensile strength and yield stress of bolts as Grade 5.6 as shown in figures (5) and (7) it can be said that bolts made from **Grade 6.4** but during manufacturing it's written 5.6 on the bolt as safety factor.

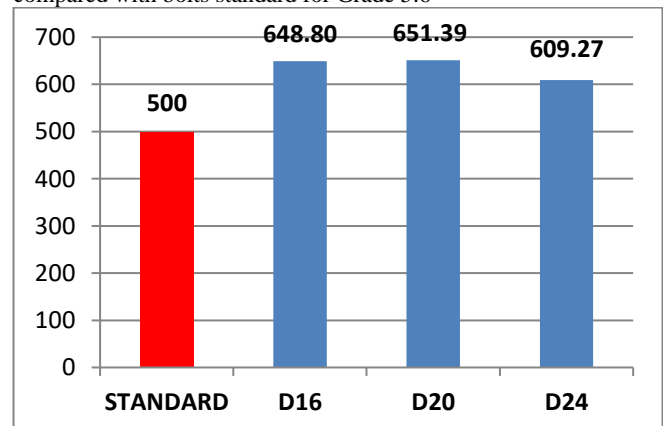
ISO 898-1:2013[E] [2] shows that maximum tensile strength of bolts of Grade 5.6 should be minimum 500 MPa as indicated in table (2), results showed that the minimum strength value is above 500 MPa, and the maximum strength value is above 760 MPa. These results are so good that these bolts do not need to be replaced in the building.

Figure (6) shows tensile strength average in MPa for each bolt size compared with bolts standard for Grade 5.6

Figure (6): shows tensile strength in MPa of all bolts Compared with bolts standard

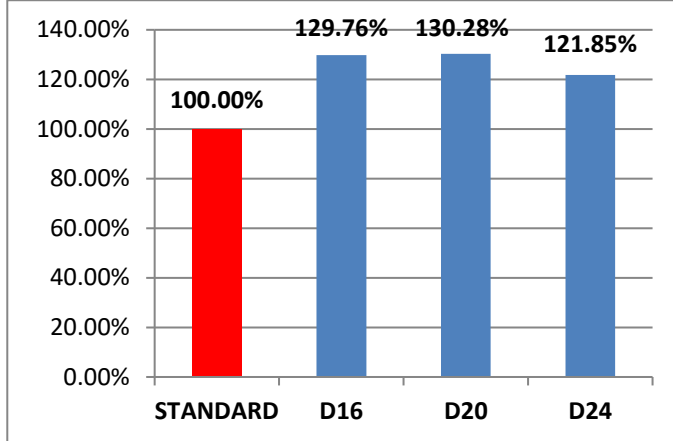
Figure (7): shows tensile strengths of all bolts as percentage from bolts standard

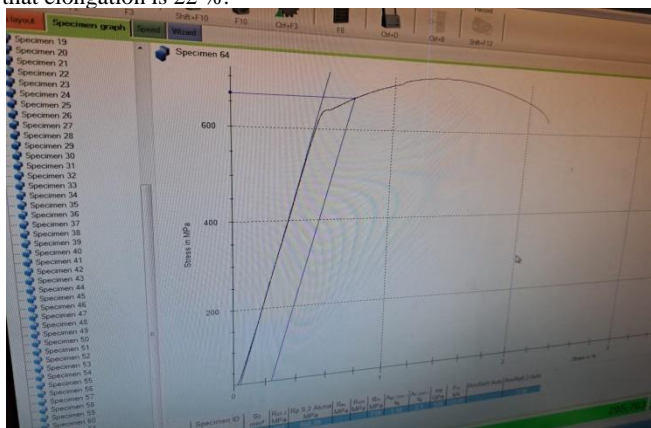
Figure (8) shows stress- strain relation for such a bolt, and it shows that yield stress compared to standards is higher than 300 MPa and maximum strength is also above 500 MPa, from the figure it is noted that elongation is 22 %.

Figure (8): Stress- strain relation for a bolt.

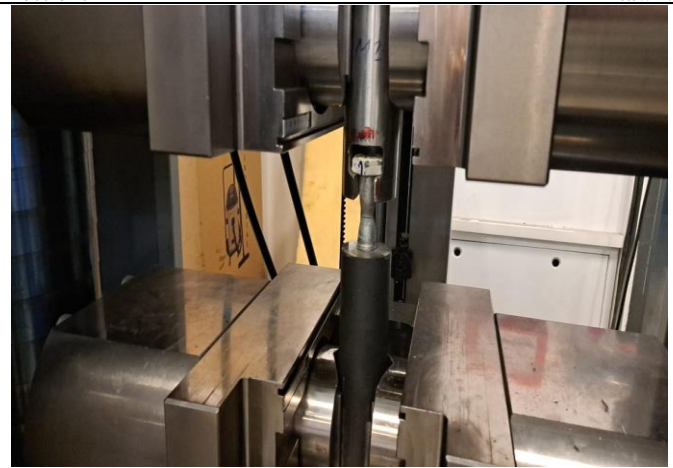
The mode of failure recognized for all tested bolts, most of them were failed in straight zone as shown in figure (9), and some failed in thread zone but not by slipping off threads as shown in figure (10), there weren't any bolt failed by stripping off the head of the bolt. All cases of failure happen after the bolt has reached the value of tensile strength which indicated in bolts standard as shown in table (2), and this can be interpreted that all bolts are in good condition and can be accepted as safe bolts.

Figure (9): shows failure of bolts in straight zone

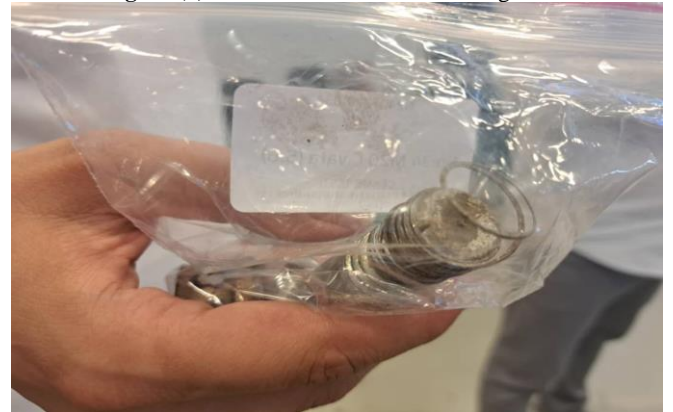
Figure (10): shows failure of bolts in thread zone
