**Steel Corrosion Control in Seawater Using Zinc sacrificial anode**Mohamed A. Khalil^a, *Elfitouri K. Ahmied^b^a Raslanuf Oil and Gas Processing Company, Libya^b Petroleum Engineering Department, Sirte University, Libya*Corresponding author: e.ahmied@su.edu.ly

Keywords: cathodic protection, zinc anodes, corrosion rate.

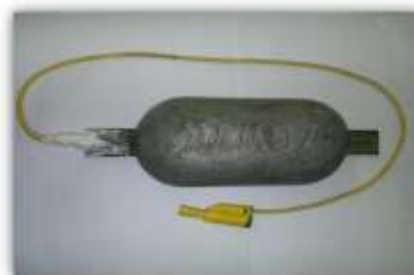
Figure. (2) sacrificial zinc anode.

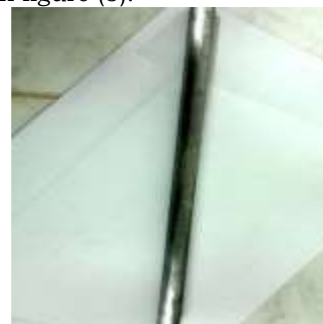
After 95 days of immersion the test sample has been removed and cleaned for evaluation of corrosion type and rate. Visual examination has been performed on the mild steel test sample and general corrosion (uniform corrosion) were noted on whole test sample surface and no any significant appearance of any localized corrosion as can be clearly confirmed by the optical photo graphs indicated in figure (3).

Figure. (3) The general corrosion on the test sample after immersion of 95 days in natural seawater environment and after removing all existing corrosion product and well surface cleaning.

1. Mild steel in static seawater immersion test for duration time of 95 days showed only general corrosion and no any visible pitting

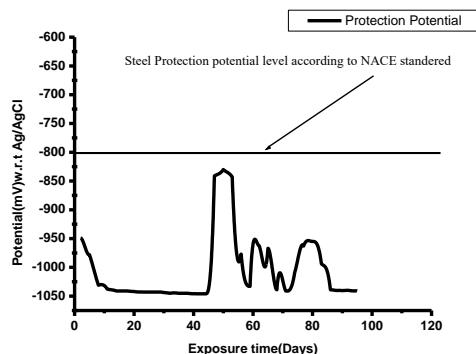
in circuit resistance (between the test sample and the wire), decreasing the zinc anode current output and the test sample (WE) protection potential consequently, fortunately the obtained protection potential during this period (7 days), does not reach the limit of NACE standard TM0497-2000, which stated that the minimum protection potential criterion should not be less than (-800 mV with respect to Ag/AgCl reference-electrode half-cell), this has been confirmed by visual monitoring results which does not reveal any changes in the water cooler and /or any visible appeared spot of rust on the steel test sample surface, during this time period, as will be discussed in detailed in the visual examination section. The bad contact problem has been eliminated and good contact has been insured which can be noticed by high negative increases in the protection potential readings from 54th day with 140 mV in magnitude and continued fluctuated between negative and positive protection potentials range (-910 mV to -1041 mV) during the duration of exposure time from 55th day to 85th day than back to steady state condition on 86th day up to the end of the experiment. All protection potential obtained result have been plotted in graph indicated in fig. (4)

Fig. (4): Demonstrates the mild steel protection potential represented by Y-axis vs. immersion time reprinted by X-axis in natural seawater environment as can be seen that the test sample received full protection potential from the zero time of immersion up to the end of the experiment.

Figure (4): Mild steel corrosion potential vs. exposure time in natural seawater environment.

After completion of 93 days, despite of the high recorded positive shift and the fluctuation in protection potential the limit of steel protection level (line indicated in the graph) was not attained as a/m, protection potential re-back to the steady state condition as can be confirmed by the a visible restoration of calcareous deposit clearly appeared on optical microscopic graph in fig. (5).

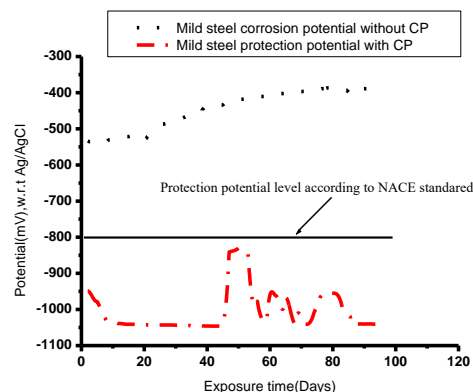
Figure (6) Illustrate the Comparison between Mild steel corrosion potential and protection potentials vs. time in natural seawater environment .as seen all corrosion potential obtained readings were above the line of steel accepted protection level, whilst all obtained protection potential readings were below protection limit line i.e. within the accepted steel protection potential level, as already experimentally confirmed, by the visual evaluation of both un cathodically (freely corroded) and cathodically protected steel test samples see figure (5).

Figure. (6): Comparison between Mild steel corrosion potential and protection potentials vs. time in natural seawater environment
