Learning Lessons from Derna Dam Failures

*Essam Saeid^a, Khalifa Eldursi^{1a}, Taoufik Al Trabelci^b

^a The University of Benghazi, Department of Earth Sciences, Benghazi Libya

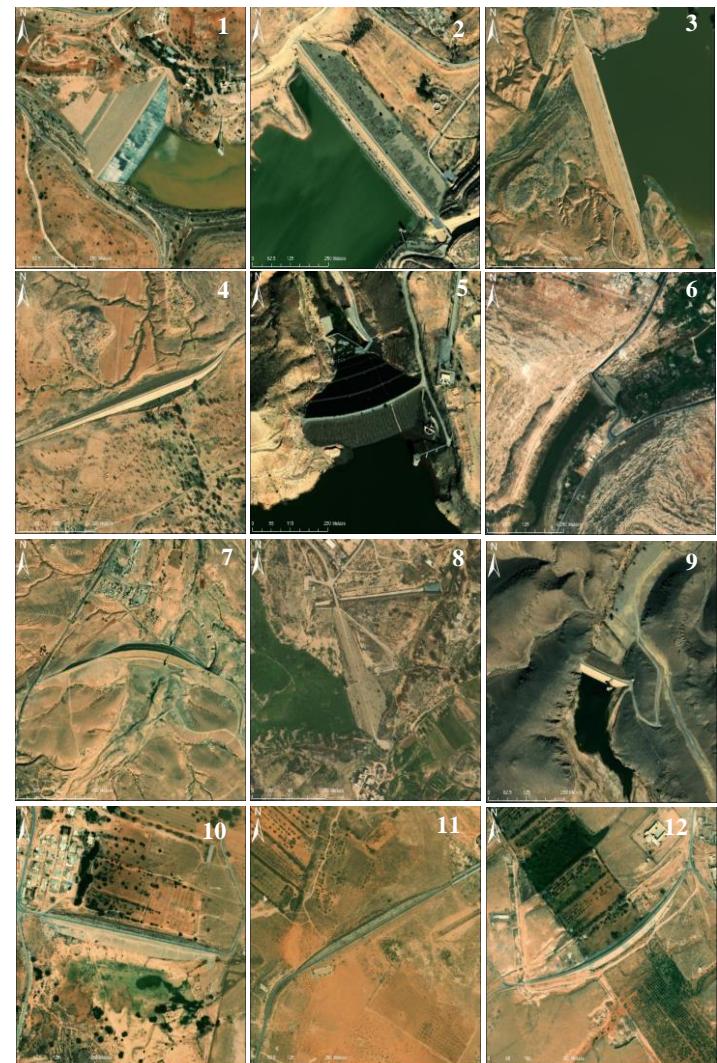
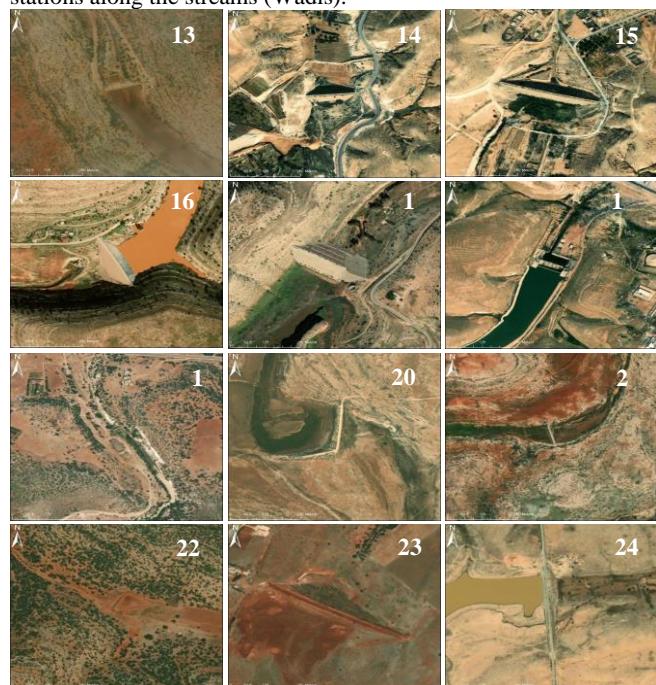
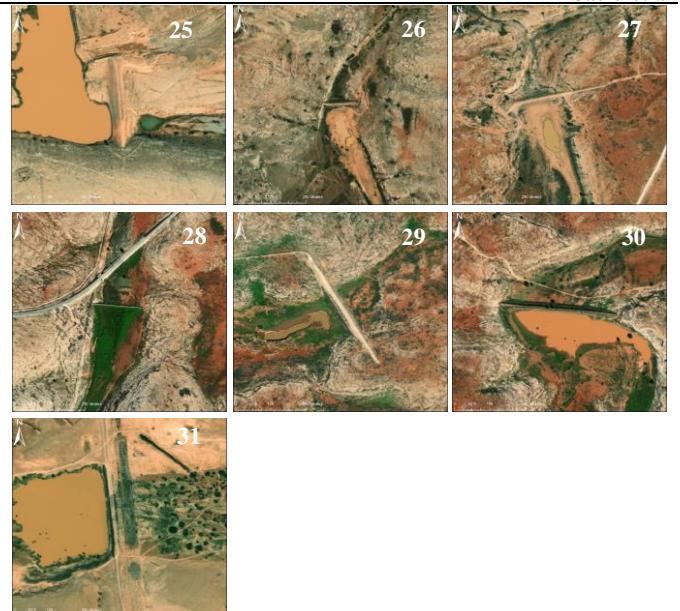
Fig (2) Satellites images for the Libyan dams. For the dam name and location, refer to Fig (1) and Table (1). Dams 1 to 9 are large dams according to (ICOLD).

Fig. (2) (continue) Satellites images for the Libyan dams. For the dam name and location, refer to Fig (1) and Table (1)
